## PRELIMINARY STRUCTURAL ASSESSMENT REPORT

**PROJECT:** Ronald Reagan Building – 14<sup>th</sup> Street ramps  
Investigation of Ceiling Failure at the 14<sup>th</sup> Street North Vehicle Ramp

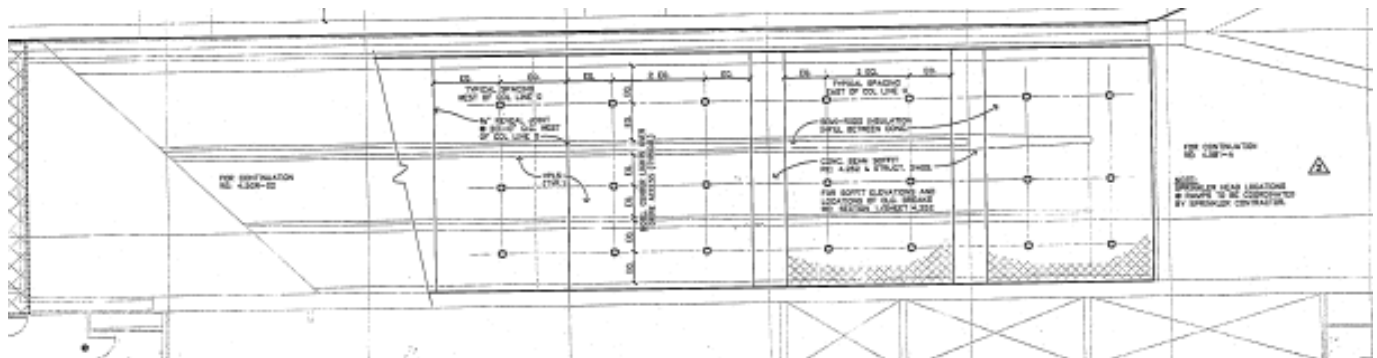
Figure 4: 14<sup>th</sup> Street North Ramp Reflected Ceiling Plan – B1 Level

The OPDQ structural engineers observed during the site visit that the ceiling at the 14<sup>th</sup> Street North Vehicle Ramp had collapsed at the second panel location by the entrance and adjacent two panels were sagging. The ceiling consists of approximately ¾” thick plaster ceiling panels approximately 10feet wide with a lath back up (Appears to have been done on site due to different colors of coating) connected to 1 ¼”x2 ½” light gage channels spaced at approximately 12 inches on center. The channels are in turn supported by light gage “C” channels spaced at approximately at the third ceiling panel points. The channels are connected to the concrete ceiling soffit above at approximately 4 feet on centers. “Eye” socket hangers or hammer drilled expansion screws (Approximately ¼” diameter by 1-¼” long) provide the hanging mechanism for the wire hangers. At some locations the ceiling panels appear to be directly hung from wires. Light gage tracks attached to the concrete ceiling by the expansion screws at approximately 12” on center provide support for the vertical light gage studs 3 ¾” deep x 1 ¾” flange that act as the framing for the bulkheads.

- 1) Keep the 14<sup>th</sup> Street North Ramp closed off and do not have anyone have access to the area.
- 2) Remove sagging and loose ceiling at the north ramp. This was verbally communicated to the Building management and contractors and work is assumed to have begun as of 04/21/2017.
